BOYD KELLER RESERVOIR DAM

INVENTORY NUMBER NDS 745

## PHASE I INSPECTION REPORT

## PHASE I REPORT NATIONAL DAM INSPECTION PROGRAM

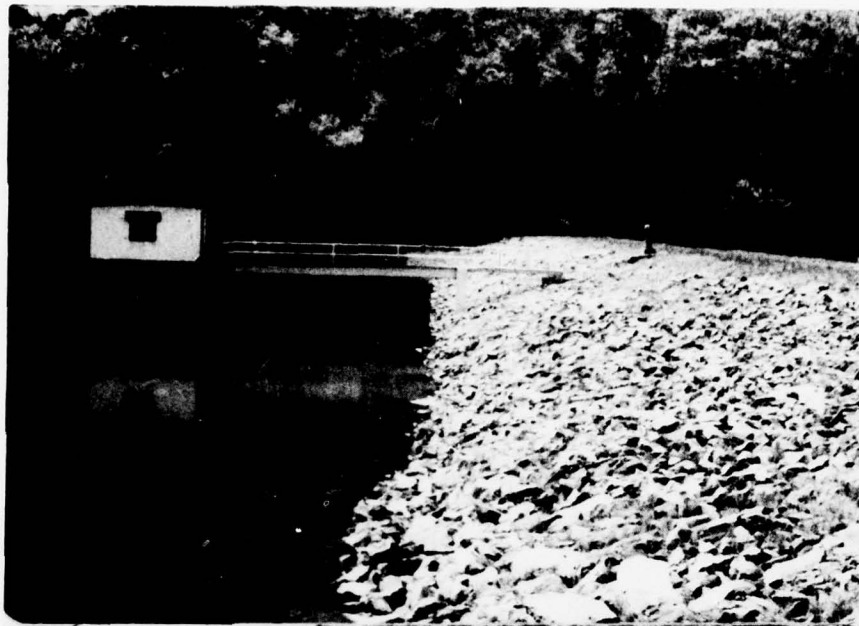
The upstream embankment slope is covered with riprap to an elevation eight feet below normal water level and appears stable. No failures or unusual conditions were noted. The downstream slope is seeded and in good condition. One low area was noted near the left abutment at the top of dam, but the cause could not be determined. The top of the backfill adjacent to the spillway walls is approximately one foot below the top of wall and could cause an early overtopping of the dam. Drains and a collection system had been installed to eliminate a wet condition below the dam. The dark color green vegetation indicated where these drains had been installed. The collector is discharging in a ditch along the access road. The effluent was clear and no movement of fines was detected. No other seepage was detected at the site.

Upstream  
Slope

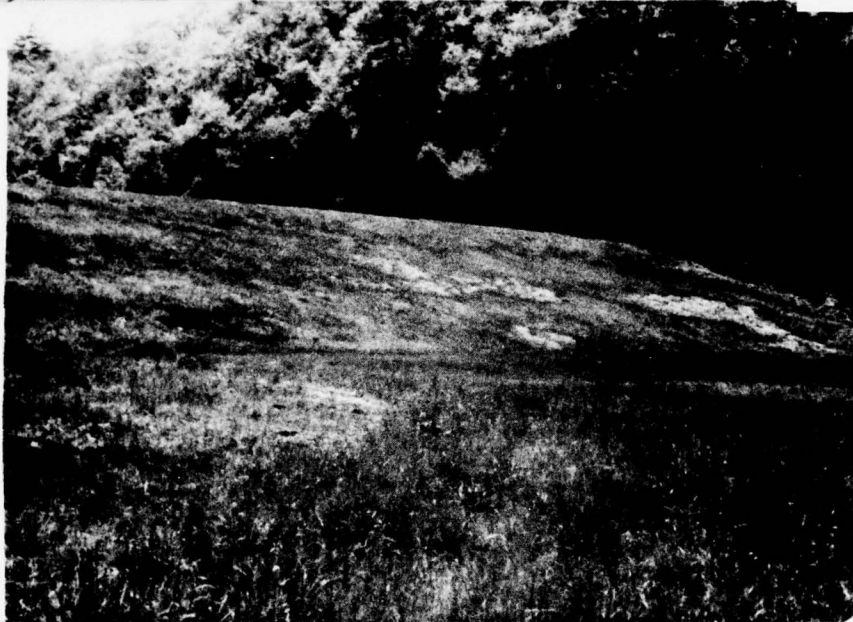
There were no observations of undue embankment distress. Considerable seepage does occur along the left abutment and the downstream toe, but the locations and extent of the leakage could not be determined because of the drains and collectors that have been installed below ground. This leakage was observed at the end of the discharge pipe.

Left Downstream  
Embankment

1. Owner should carefully monitor the volume of leakage discharged from the collector system, and observe any turbidity of the water, and contract for repairs if such need is indicated.
2. Owner should backfill to top of spillway walls and fill the low area on top of embankment.

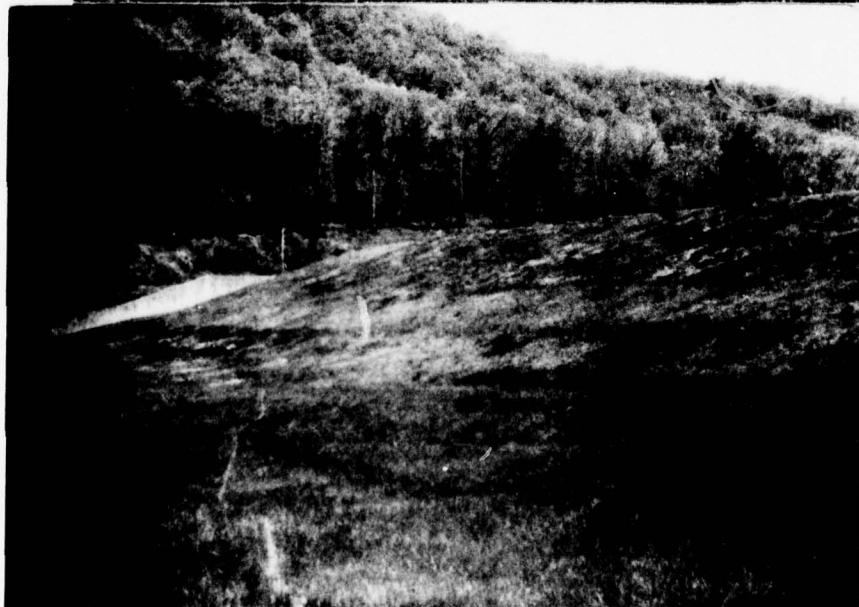
Right Downstream  
Embankment

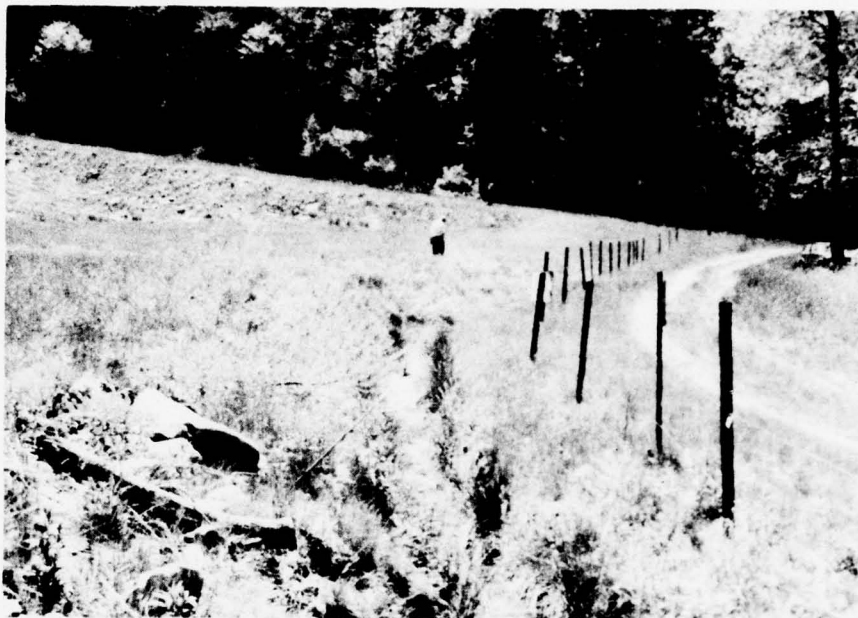
The only reported post construction has been the installation of drains and a collection system to eliminate a downstream wet condition. Seepage is discharging from this collector, but the water is clear, showing no movement of fines.

Downstream  
Toe

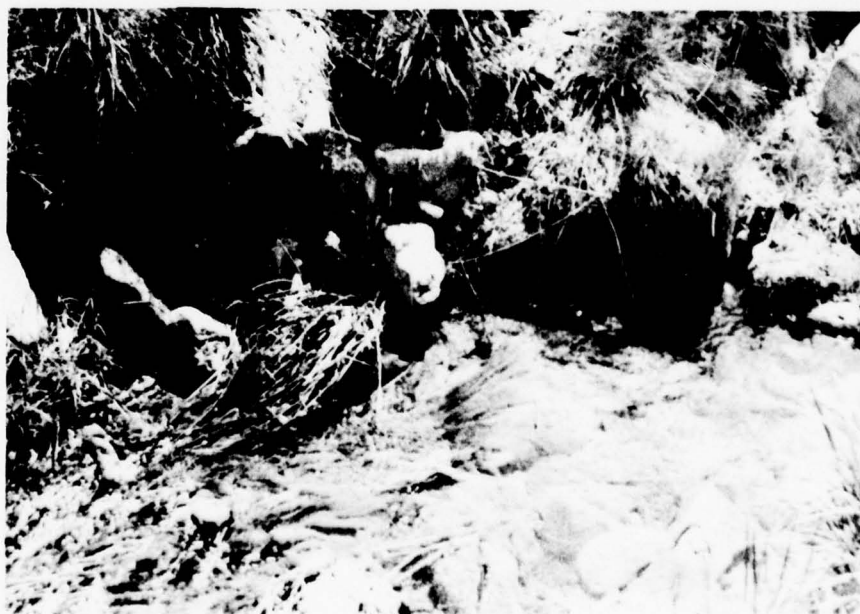
Downstream  
Creek

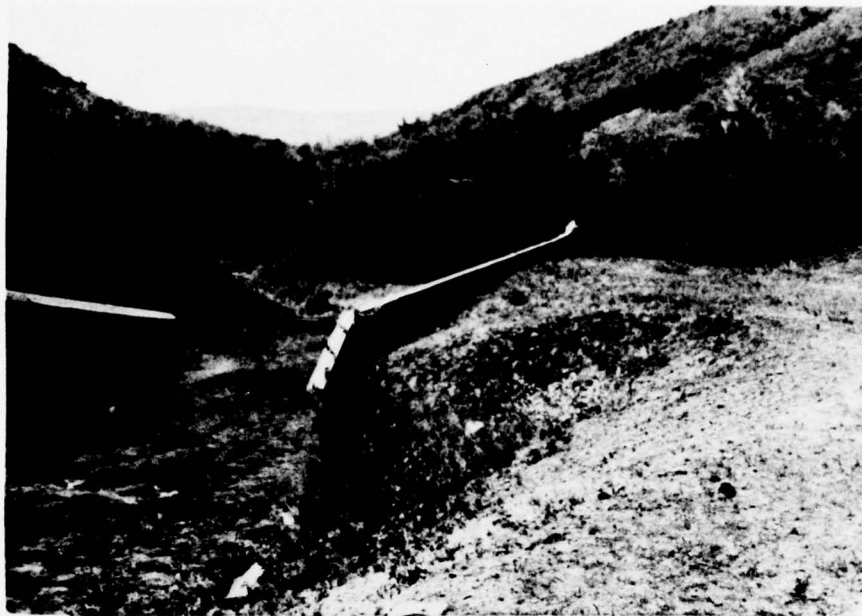
"Split"  
Spillway

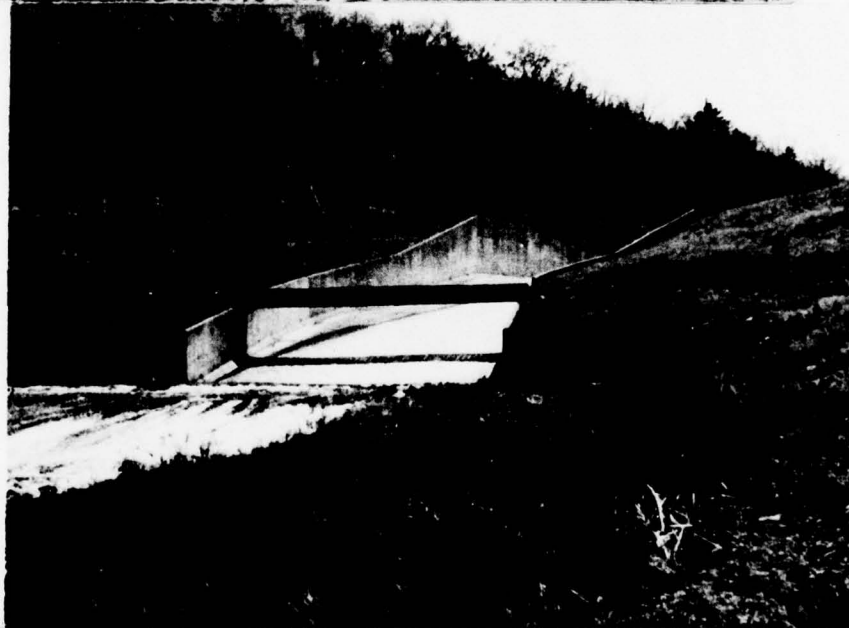
Spillway  
Chute

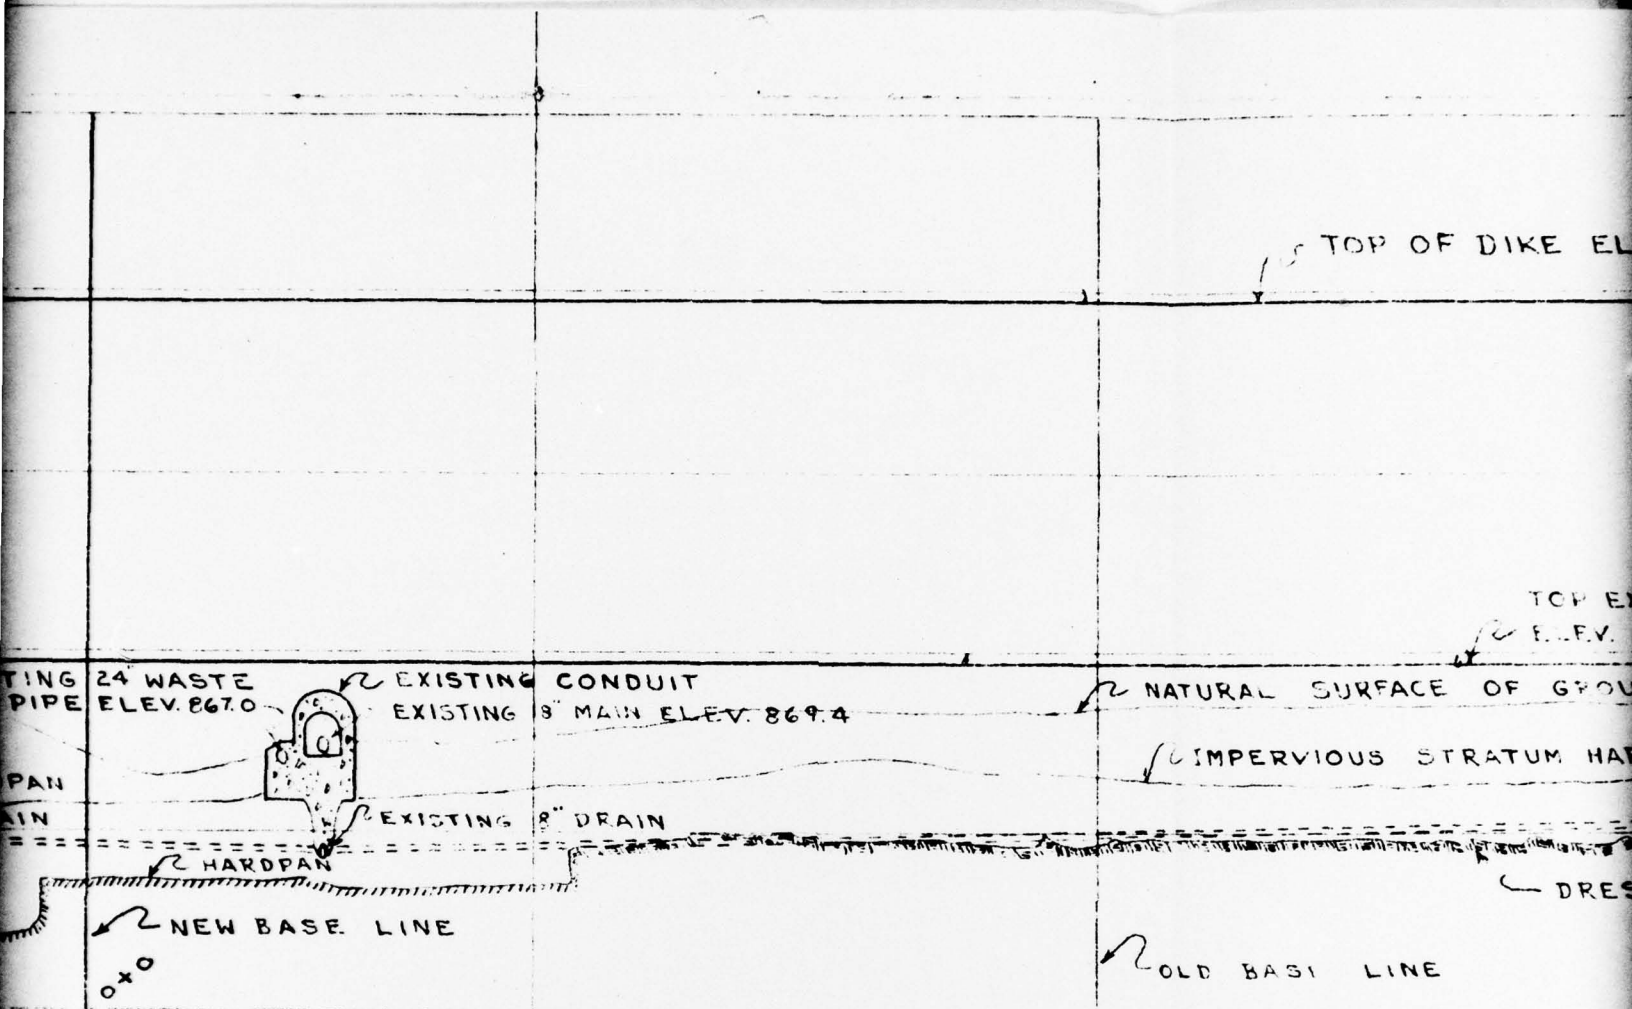
NGITUDINAL SECTION THRU COREWALL  
 SCALE 1" = 20'

One drawing included with the contract drawings is a detail of the foundation conditions of the core wall constructed in 1912-15. This drawing indicates a portion of the corewall was constructed on "hardpan", since rock was evidently at a grade too low to reach.

However, not all of the core wall was founded in bedrock. The central area, identified as "hardpan" on the drawing, is of unknown and could be a point of weakness. Also, the east abutment of the core wall may have been founded in overburden, or at least, in partially disintegrated bedrock. If leakage is ever detected at either place, it should be carefully monitored.
